# Second Five - Year Review Report

## CERCLA Sites at Naval Submarine Base New London

Groton, Connecticut

December 2006

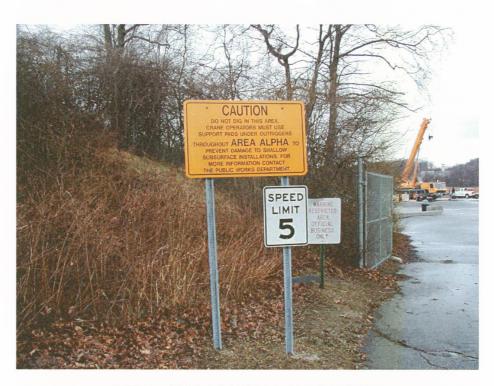
SITE 2 – AREA A LANDFILL AND WETLAND
SIGN AT THRESHER AVENUE ENTRANCE OF AREA A LANDFILL
APRIL 4, 2006
NSB-NLON, GROTON, CONNECTICUT. CTO 038

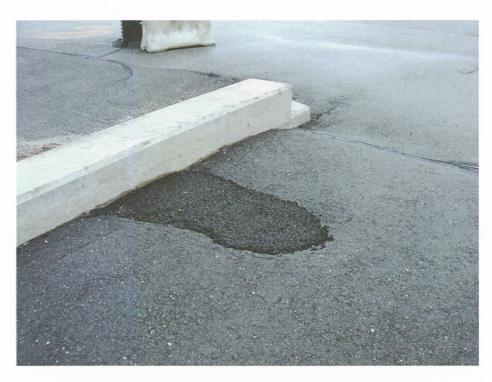
SITE 2 – AREA A LANDFILL AND WETLAND
COLD PATCHED DEPRESSION ALONG INLET HEADWALL OF CULVERT 2
APRIL 4, 2006
NSB-NLON, GROTON, CONNECTICUT. CTO 038

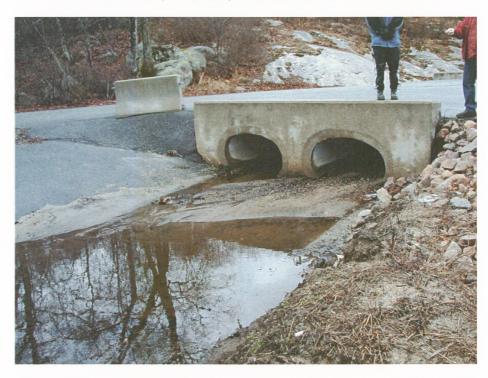
SITE 2 – AREA A LANDFILL AND WETLAND OUTLET OF CULVERT 2 FACING SOUTHWEST APRIL 4, 2006 NSB-NLON, GROTON, CONNECTICUT. CTO 038

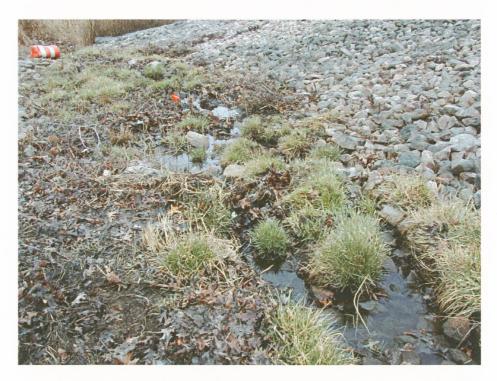
SITE 2 – AREA A LANDFILL AND WETLAND DEBRIS CLOGGING CHANNEL C APRIL 4, 2006 NSB-NLON, GROTON, CONNECTICUT. CTO 038

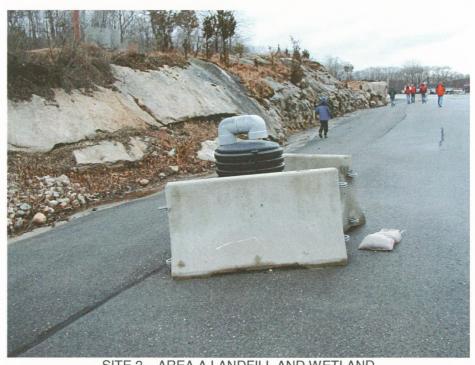
SITE 2 – AREA A LANDFILL AND WETLAND GAS VENT 18 – REQUIRES THIRD BARRIER FOR COMPLETE PROTECTION AND SCREEN ON VENT APRIL 4, 2006 NSB-NLON, GROTON, CONNECTICUT. CTO 038

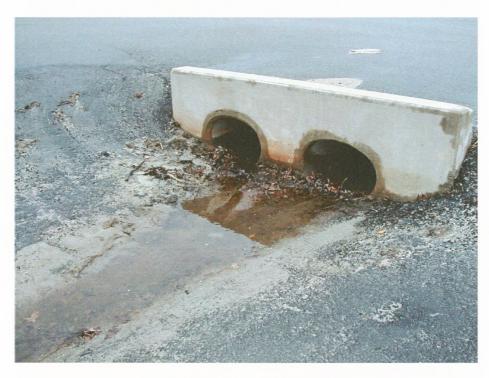
SITE 2 – AREA A LANDFILL AND WETLAND
OUTLET OF CULVERT 1 FACING SOUTHWEST; MINOR EROSION OF CHANNEL A
APRIL 4, 2006
NSB-NLON, GROTON, CONNECTICUT. CTO 038

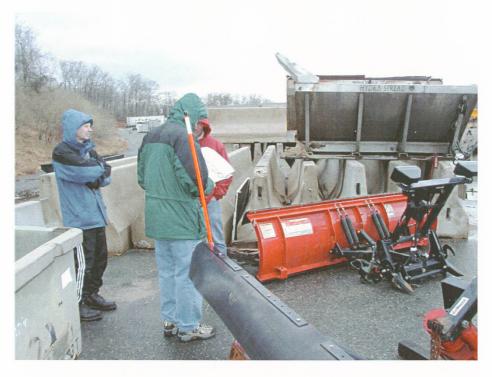
SITE 2 – AREA A LANDFILL AND WETLAND
BARRIERS AND EQUIPMENT COVERING MONITORING WELLS NEAR CULVERT 1
APRIL 4, 2006
NSB-NLON, GROTON, CONNECTICUT. CTO 038

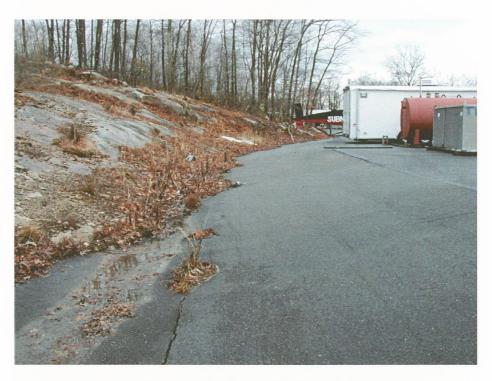
SITE 2 – AREA A LANDFILL AND WETLAND
DEBRIS AND VEGETATION IN CHANNEL A NEAR GAS VENT 7
APRIL 4, 2006
NSB-NLON, GROTON, CONNECTICUT. CTO 038

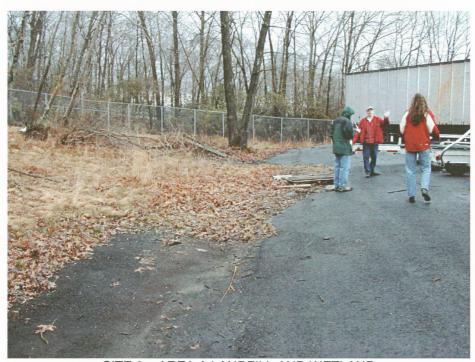
SITE 2 – AREA A LANDFILL AND WETLAND DEBRIS AND VEGETATION IN CHANNEL A NEAR GAS VENT 2 APRIL 4, 2006 NSB-NLON, GROTON, CONNECTICUT. CTO 038

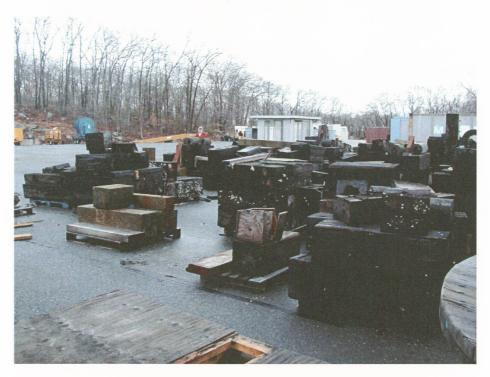
SITE 2 – AREA A LANDFILL AND WETLAND
TREATED TIMBERS COVERING MONITORING WELLS 2LOW1S AND
OTHERS IN NORTHWESTERN PART OF CAP
APRIL 4, 2006
NSB-NLON, GROTON, CONNECTICUT. CTO 038

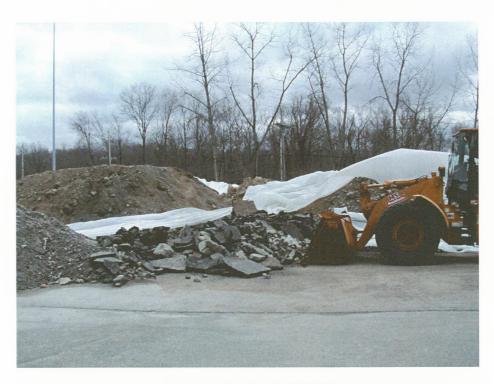
SITE 7 – TORPEDO SHOPS CONTAMINATED SOIL STOCKPILES ALONG WEST SIDE OF BUILDING 325 APRIL 4, 2006 NSB-NLON, GROTON, CONNECTICUT. CTO 038

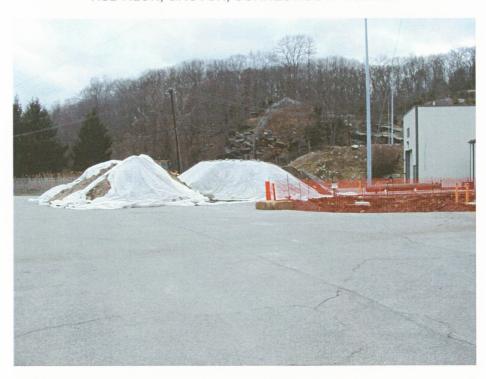
SITE 7 – TORPEDO SHOPS
EXCAVATION ALONG WESTERN SIDE OF BUILDING 325 AND
CONTAMINATED SOIL STOCKPILES FACING NORTH
APRIL 4, 2006
NSB-NLON, GROTON, CONNECTICUT. CTO 038

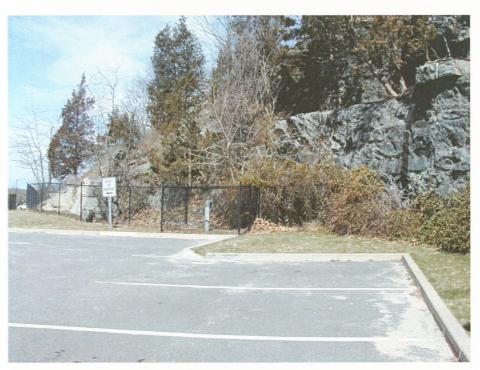
SITE 8 – GOSS COVE LANDFILL
GAS VENT L – NO LOCK ON GATE OR SCREEN ON VENT
LOOKING NORTHWEST
APRIL 3, 2006
NSB-NLON, GROTON, CONNECTICUT. CTO 038

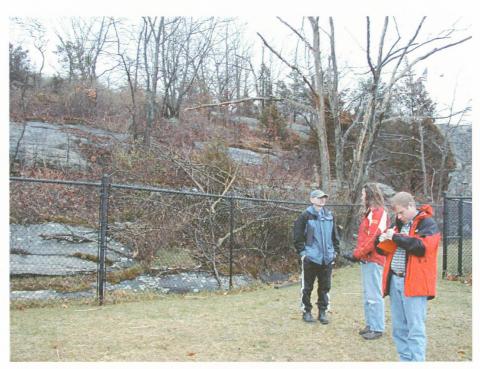
SITE 8 – GOSS COVE LANDFILL BRUSH AGAINST FENCE NEAR GAS VENT L LOOKING SOUTHEAST APRIL 4, 2006 NSB-NLON, GROTON, CONNECTICUT. CTO 038
